**Flood Control Project Maintenance
Levee Inspections**

Fall 2018 Levee Maintenance Deficiency Summary Report

Sacramento River Basin

**Flood Control Project Maintenance
Levee Inspections****LMA District Cover Sheet****Fall 2018 Levee Inspection Results****Sutter Maintenance Yard Maintenance Area 0013**

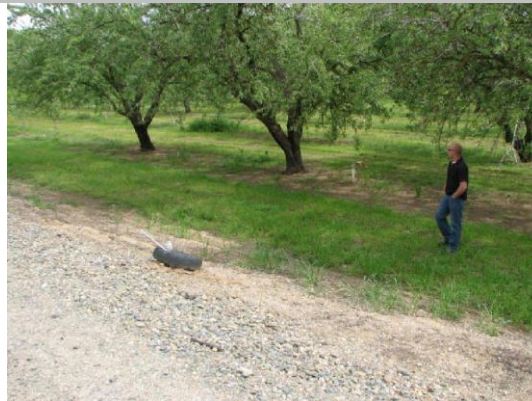
Photo 2 of 3 : UCIP_FA_2018_53313_66683.jpg

Air Vent located on WS.

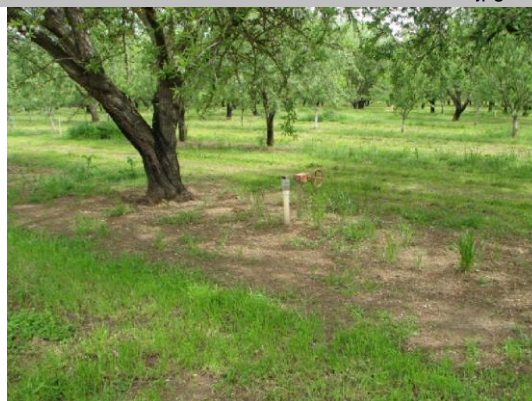
Photo 3 of 3 : UCIP_FA_2018_53313_66681.jpg

Air vent and gate located in channel. Unable to determine if part of crossing.

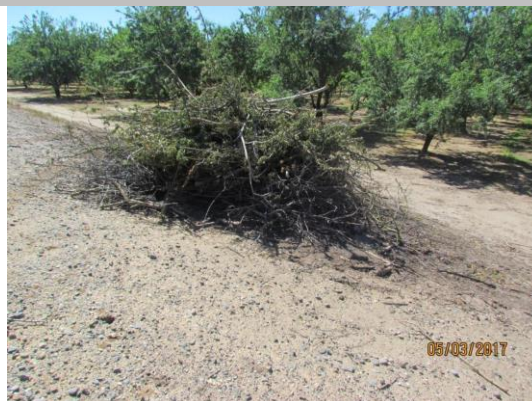
Photo 1 of 1 : FA_2018_MA0013_300_89_20180905_00012.jpg

LM Start	0.46	Rating **	M	Issue No.	89
LM End	0.46	Issue Type +	En	Location *	LS
Category	Earthen Levee			GPS Latitude/Longitude	
				Start	End
Item	Encroachments			39.591162 °	39.591162 °
				-121.701820 °	-121.701820 °
DWR ID	DWR_MA0013_01_s_2017_89				
Comment Code					
PR : Prunings					
Inspector Comment					
Remove the prunings from the landside slope.

View of prunings along the landside slope.

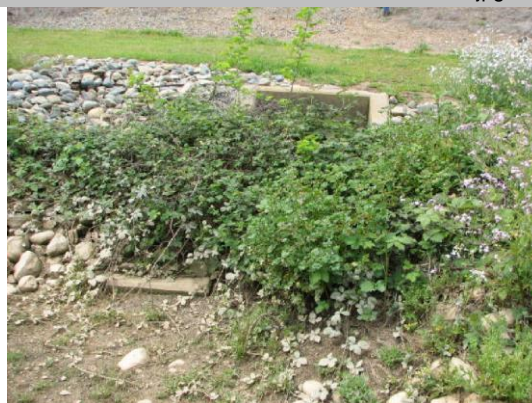
Photo 3 of 3 : UCIP_FA_2018_52938_66698.jpg

WS headwall, rock protection, and outlet blocked by shrub.

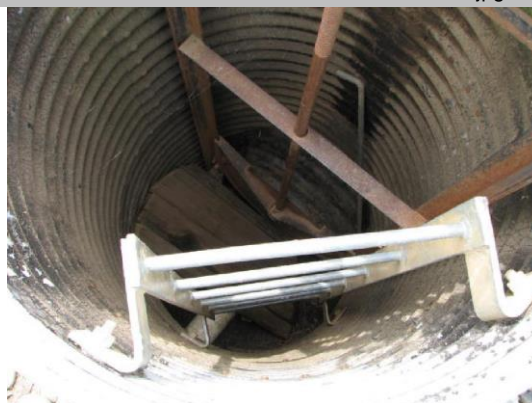
Photo 3 of 3 : UCIP_FA_2018_52183_66702.jpg

Positive closure device on WS slope, panel lid fell in.

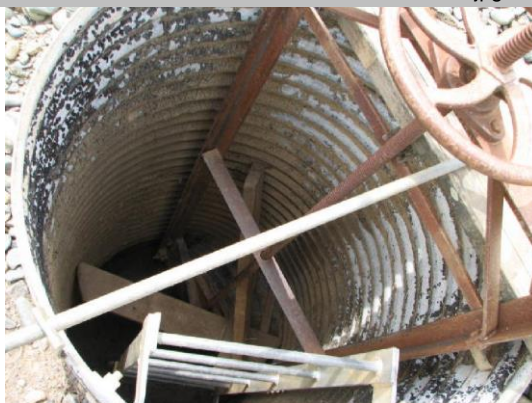
Photo 3 of 3 : UCIP_FA_2018_52184_66707.jpg

Corrugated metal riser on WS slope. Lid panel blocking gate.

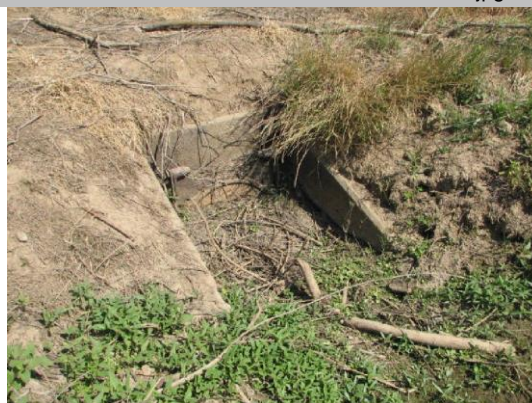
Photo 3 of 3 : UCIP_FA_2018_52201_66791.jpg

View of WS flap gate buried.

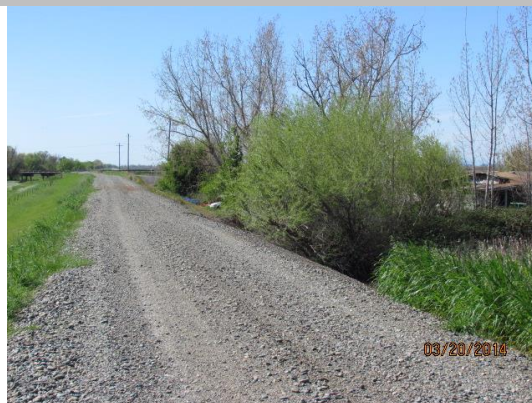
Photo 1 of 1 : FA_2018_MA0013_300_5_20180905_00002.jpg

View of the overgrown trees along the landside slope and toe.

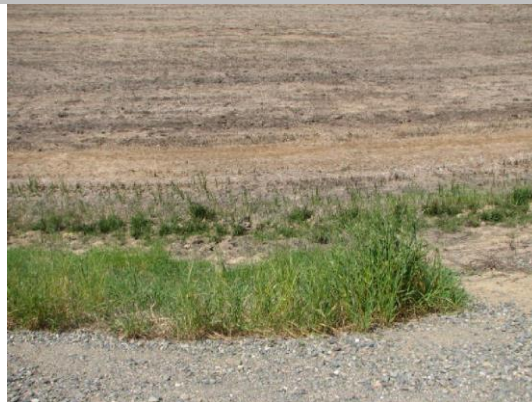
Photo 2 of 2 : UCIP_FA_2018_52240_66973.jpg

View of LS slope and toe. Unable to find welded plate on LS.

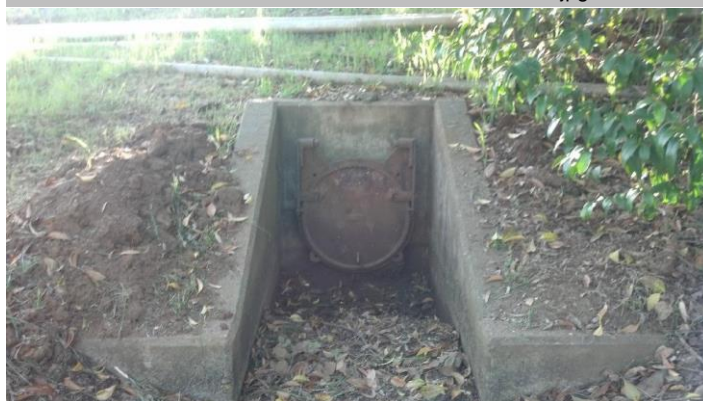
Photo 2 of 3 : UCIP_FA_2018_52111_45642.jpg

Headwall and flap gate on WS. Soil and pipes stockpiled next to headwall.

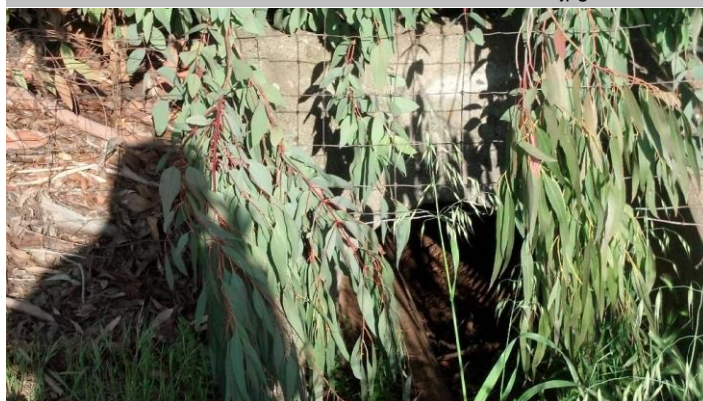
Photo 3 of 3 : UCIP_FA_2018_52111_45643.jpg

LS headwall blocked by overgrown branches.

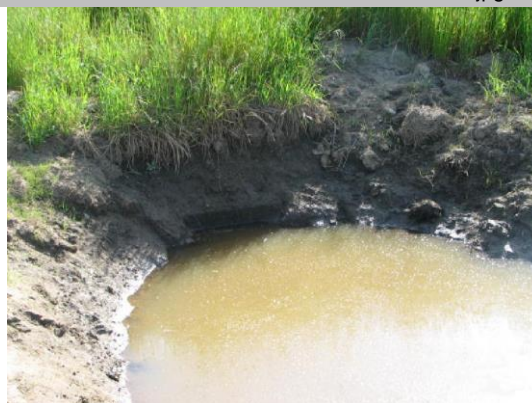
Photo 3 of 3 : UCIP_FA_2018_52121_67096.jpg

View of flap gate submerged on WS toe.

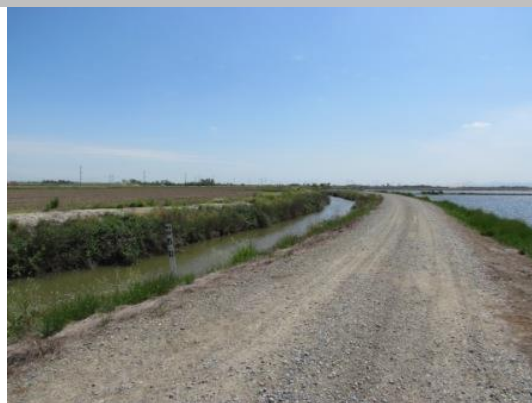
Photo 1 of 1 : FA_2018_MA0013_301_911_20180905_00023.jpg

View of agricultural ditch along the toe.

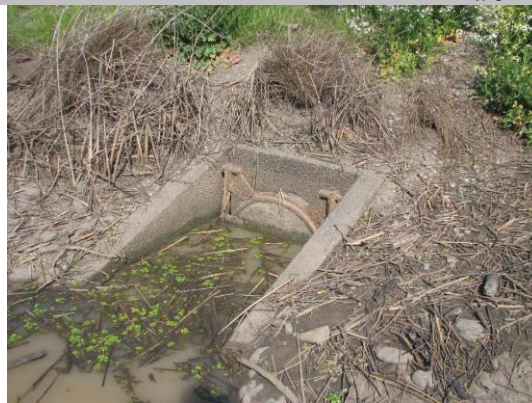
Photo 2 of 3 : UCIP_FA_2018_52124_67116.jpg

Unable to determine condition of flap gate on WS due to high water.

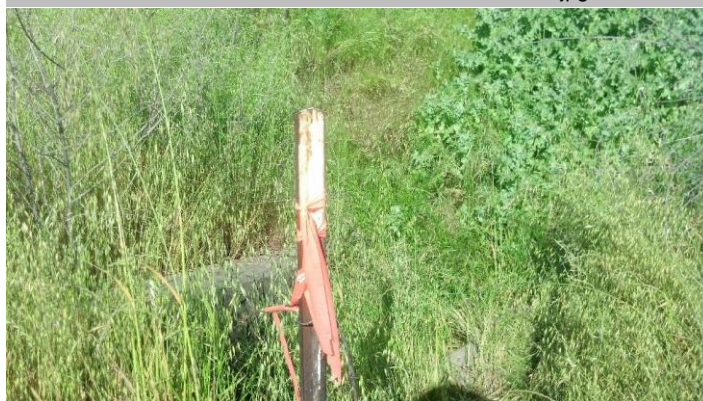
Photo 2 of 3 : UCIP_FA_2018_52156_67343.jpg

Dense vegetation covering the majority of the WS. WS headwall difficult to see through dense vegetation.

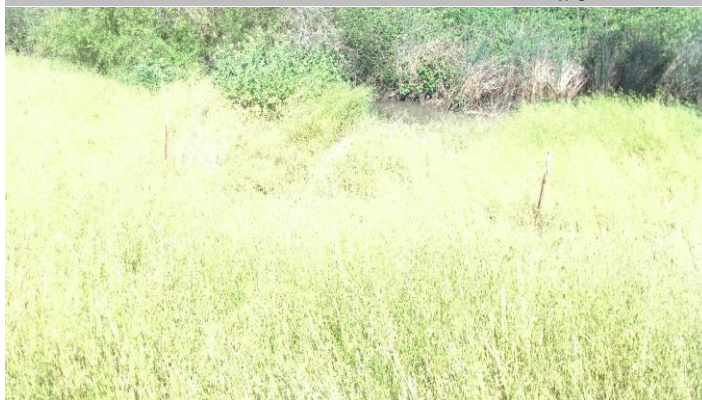
Photo 2 of 3 : UCIP_FA_2018_52157_67351.jpg

View of WS slope. Limited inspection due to the dense vegetation.

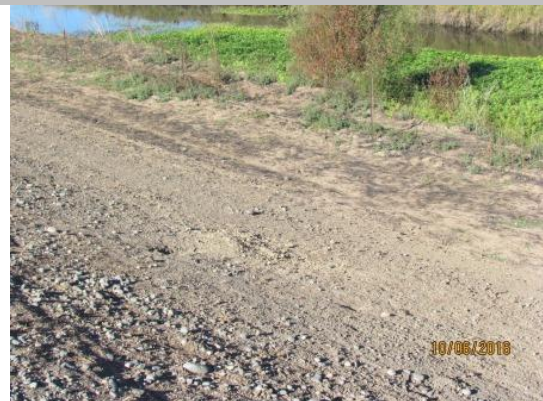
Photo 1 of 1 : FA_2018_MA0013_301_71_20180905_00020.jpg

View of the rodent holes along the landside slope.

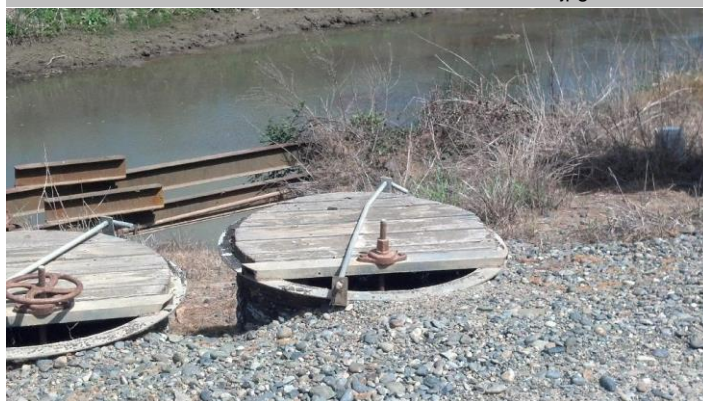
Photo 2 of 3 : UCIP_FA_2018_53320_67407.jpg

Corrugated metal pipe riser for pipe 1 of 3. Slide gate is missing handle.

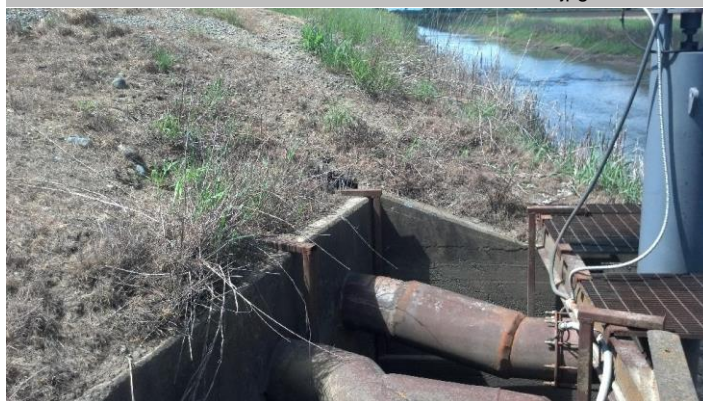
Photo 3 of 3 : UCIP_FA_2018_53320_67409.jpg

Sink hole observed behind WS headwall at the downstream edge of headwall. (Sink hole picture 1 of 2)

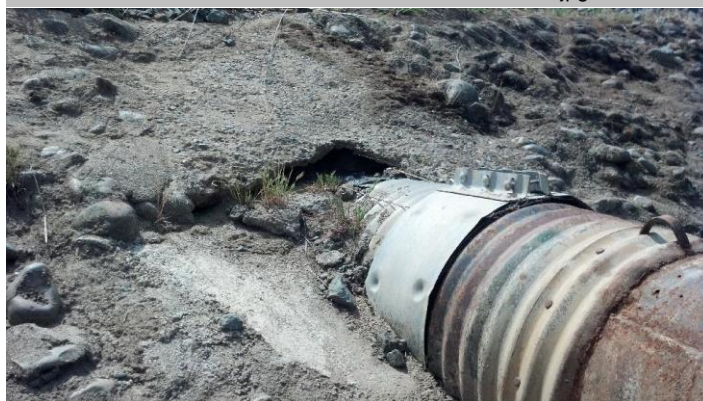
Photo 2 of 3 : UCIP_FA_2018_52168_67451.jpg

View of WS daylight. Hole present at pipe daylight.

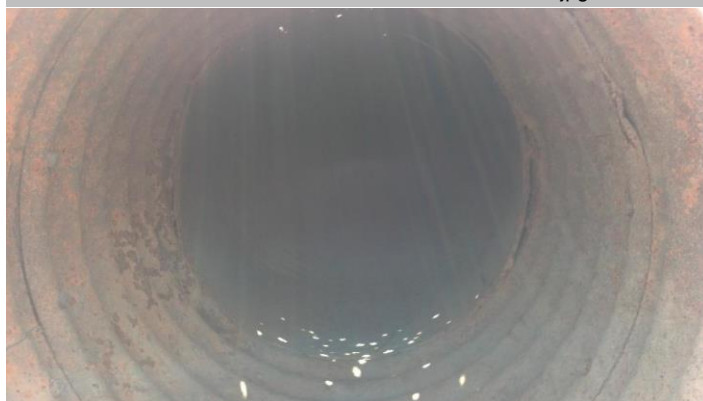
Photo 3 of 3 : UCIP_FA_2018_52168_67450.jpg

WS-view of internal pipe with severe corrosion-holes present along pipe wall.

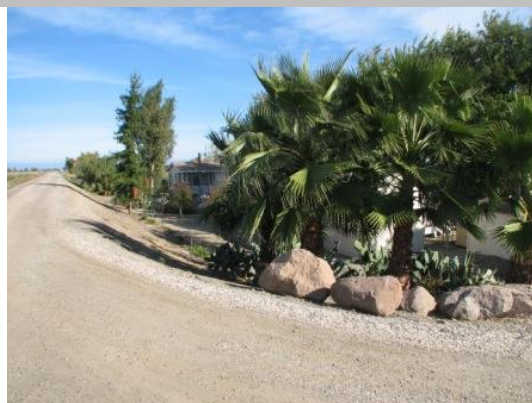
Photo 1 of 1 : FA_2018_MA0013_301_4_20180905_00001.jpg

View of landscaping along the toe.
